July 20, 2020

Indian Hills Subdivision
Cove 9 Bridge
Flood Damage Inspection
Cochran Project SC20-1110

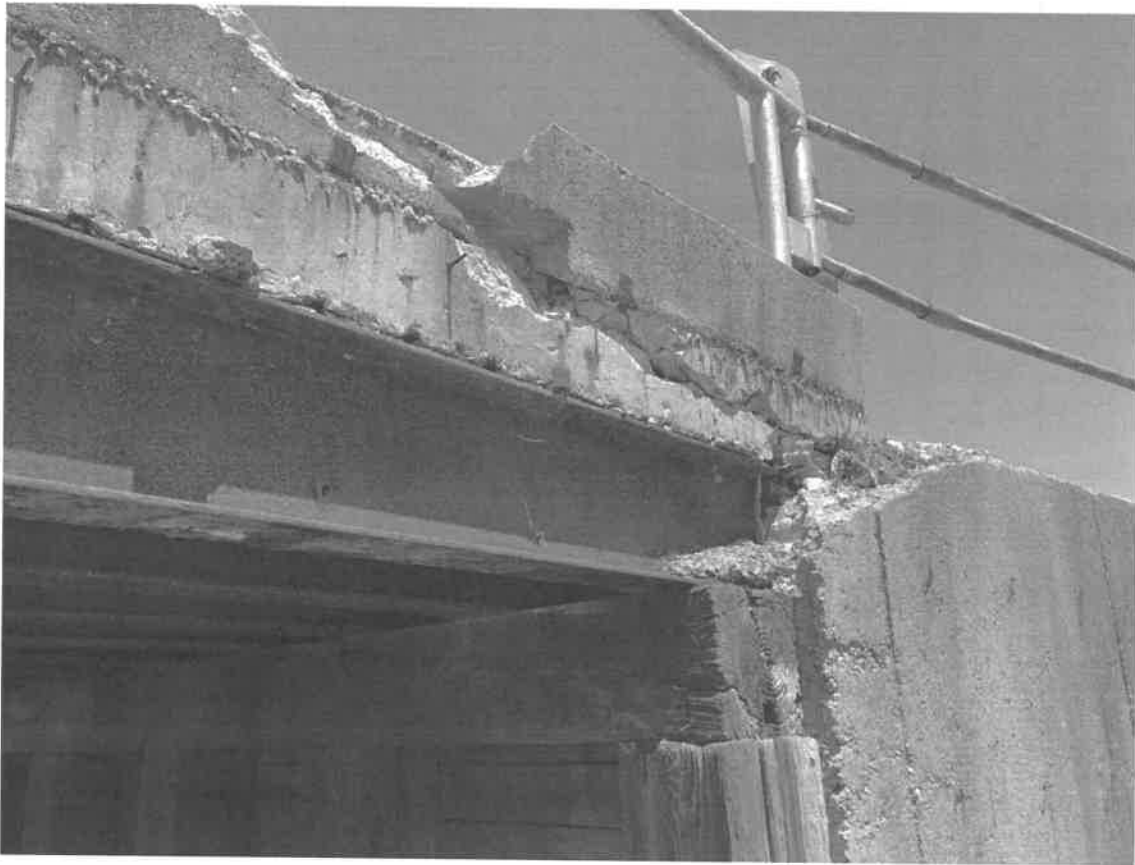
This picture shows the south beam at the time of the curb inspection.

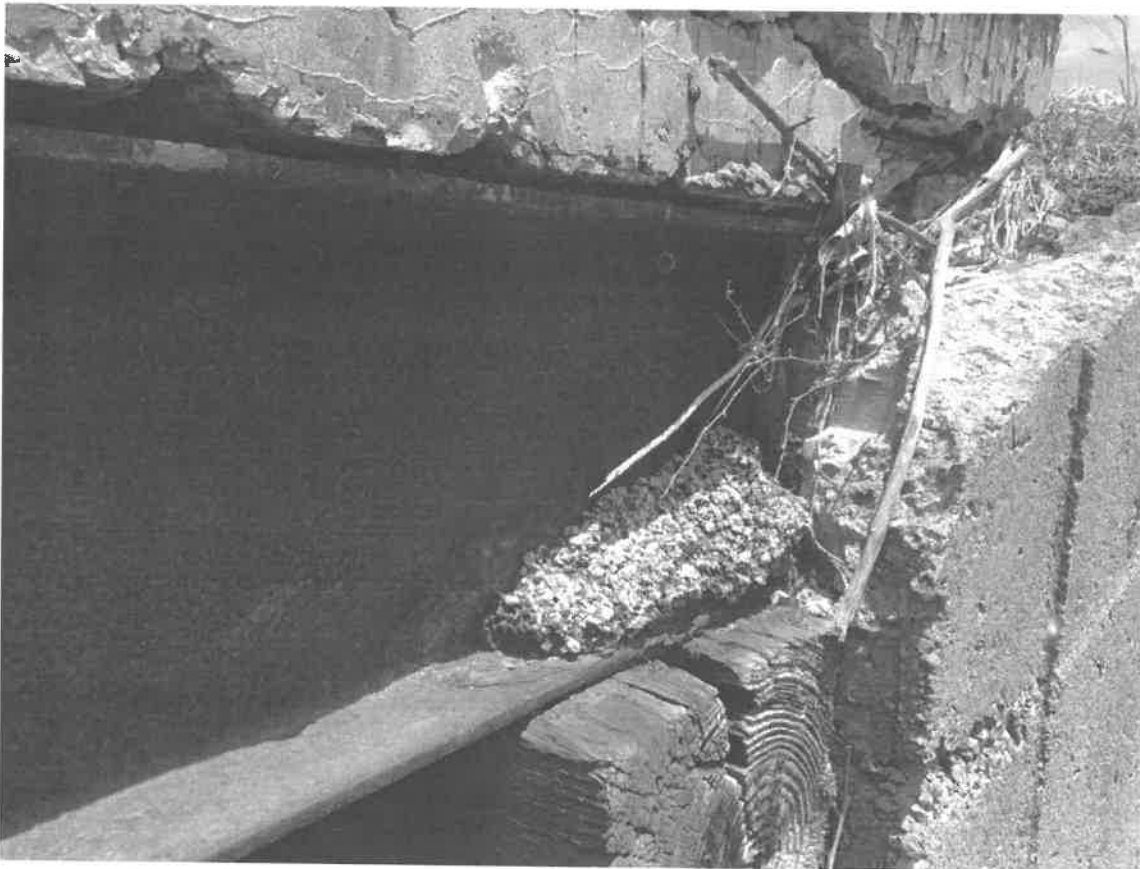
We went underneath the bridge (in a boat) to observe the current condition. The east end of the beam on the south side of the bridge has been shifted slightly to the north. It is also noticeably separated from the slab. This is the upstream side of the bridge and could be explained due to water pressure and being impacted by drift and or debris carried by the flood.

The damage caused by the flood continues to emphasize the poor condition of the bridge. The shifting and puncture of the south beam emphasize the severe deterioration of the steel members and their connection to the slab.

IMG_2106 This picture, taken after the flood, shows that the beam has shifted.

The ongoing deterioration of the bridge deck, beams and substructure indicate the need to control the weight of traffic on the bridge. Additionally, the cavity behind the west end bent could allow the roadway to collapse at any time. It is our recommendation that a Load Limit of 12 Tons be placed on the bridge to prevent large trucks such as trash trucks and dump trucks from using the bridge and accelerating the deterioration.

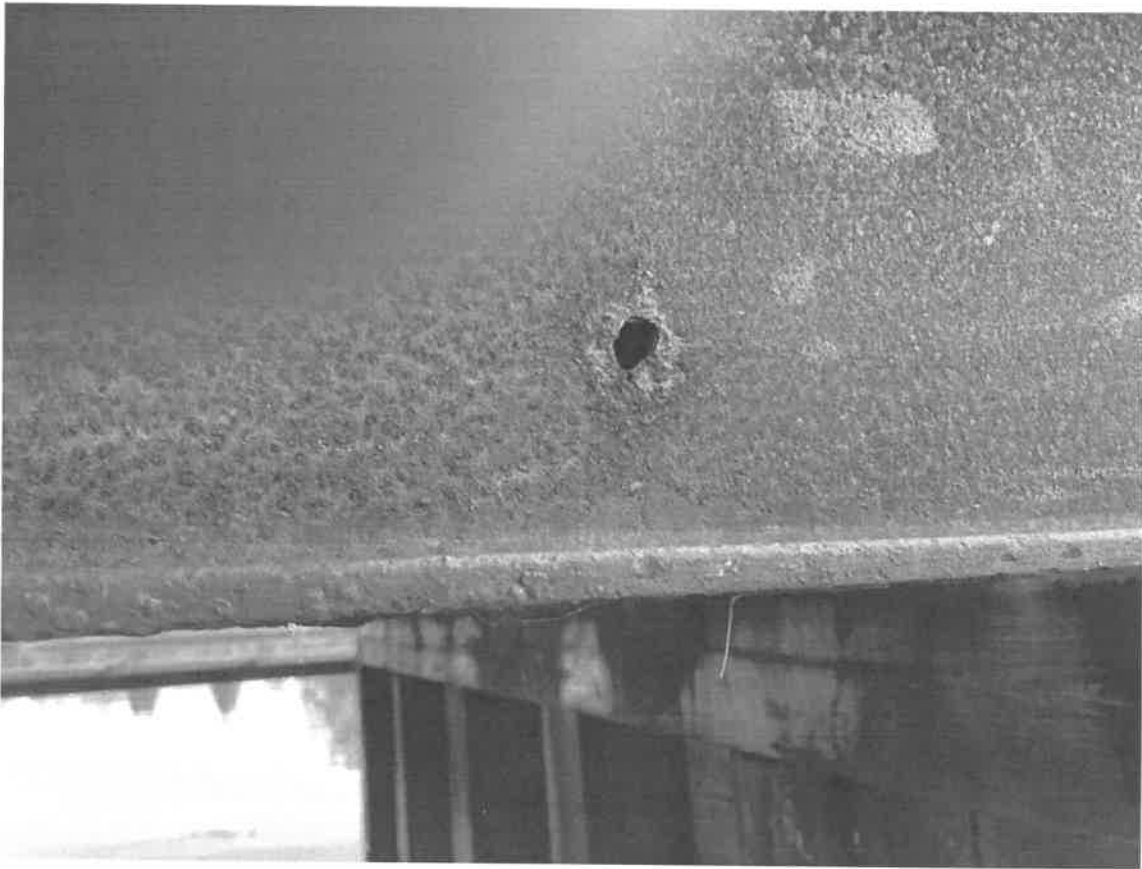
A hole has also appeared in the web of this beam where there was previously heavy scale. This too, could be explained by impact from drift. It also indicates that the webs of the beams, at least this one, are severely deteriorated.

The hole is now completely open through the web.

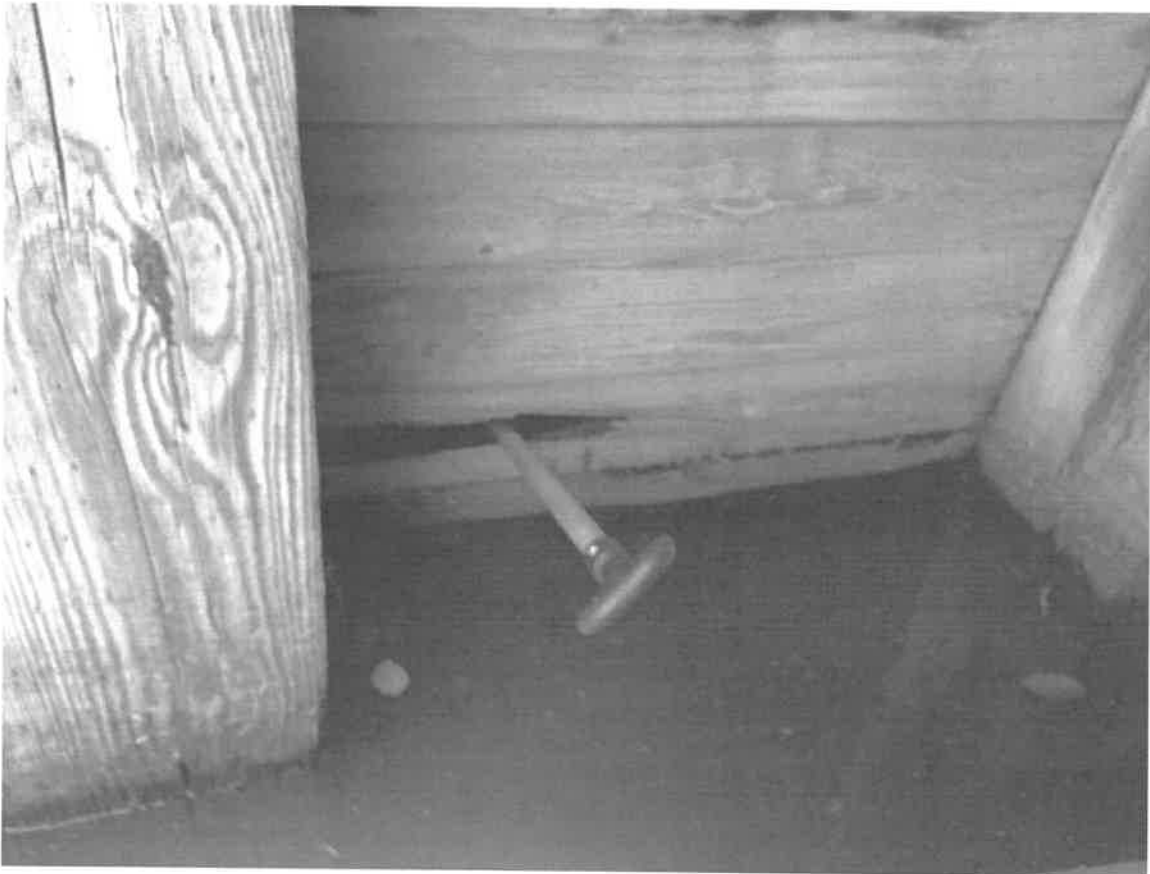
There was what appeared to be a small rotten spot on the boards of the back wall on the west end bent. We investigated further by pushing an oar into the hole and discovered a large cavity behind the end bent wall. It was impossible to determine the vertical dimensions of the cavity, but the oar went in over 3' before hitting anything. It was determined that the cavity extended below the water line, but the depth could not be determined.

The cavity behind the west end bent is also of concern and needs to be monitored very closely. That size of cavity could allow a collapse of the roadway to occur quickly and without warning.

IMG_2110 The oar went over 3' into the cavity at the west end bent.

The cavity behind the west end bent is of concern. If that were to collapse during the night a traveling vehicle might not be able to stop in time. The roadway should be closely monitored morning and evening to detect early signs of roadway collapse. We would suggest to be on the safe side and go ahead and excavate the cavity and backfill with rock or concrete.

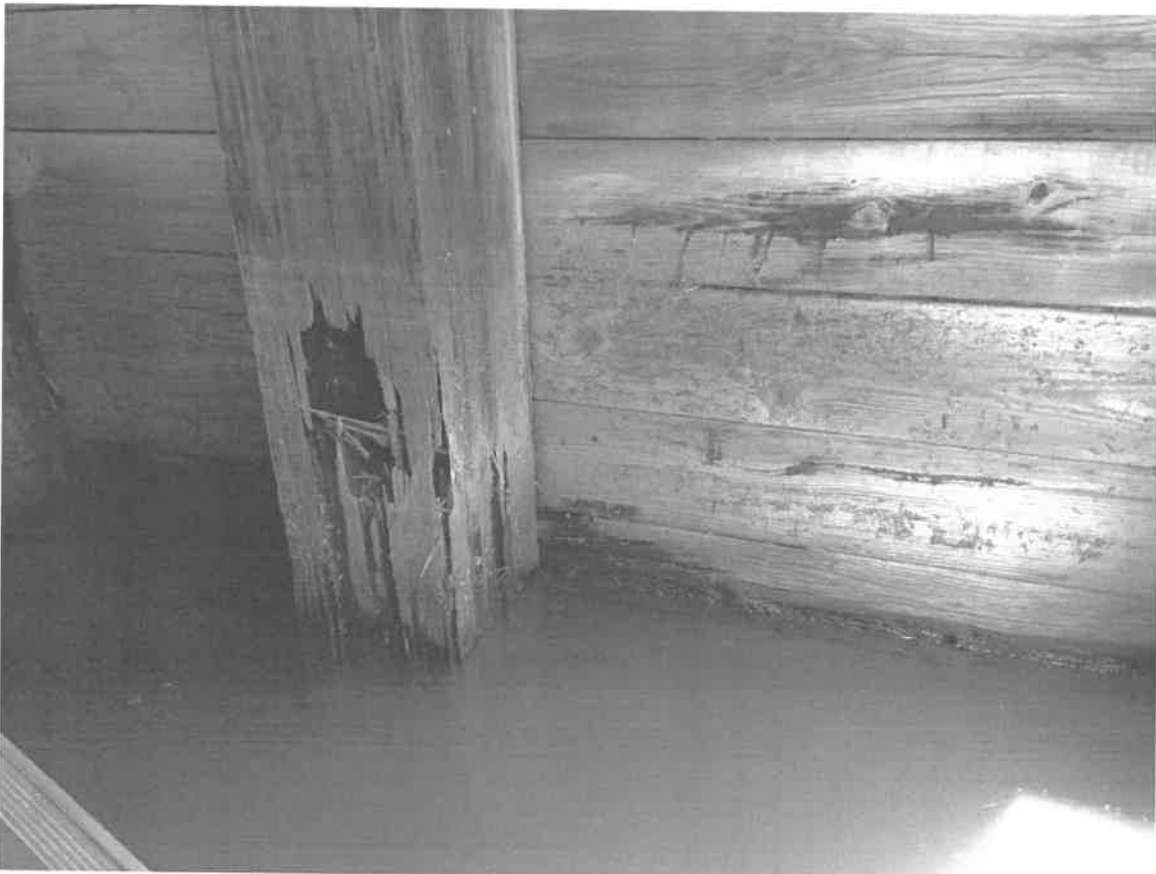
Mary Beth had previously provided me with pictures of being able to penetrate the timber pile with a screw driver. The cracks in the timber pile are not new, but the saturation and drying cycle may have caused them to expand. This reduces the load capacity of the pile.

IMG_2108 Showing deterioration of timber pile.

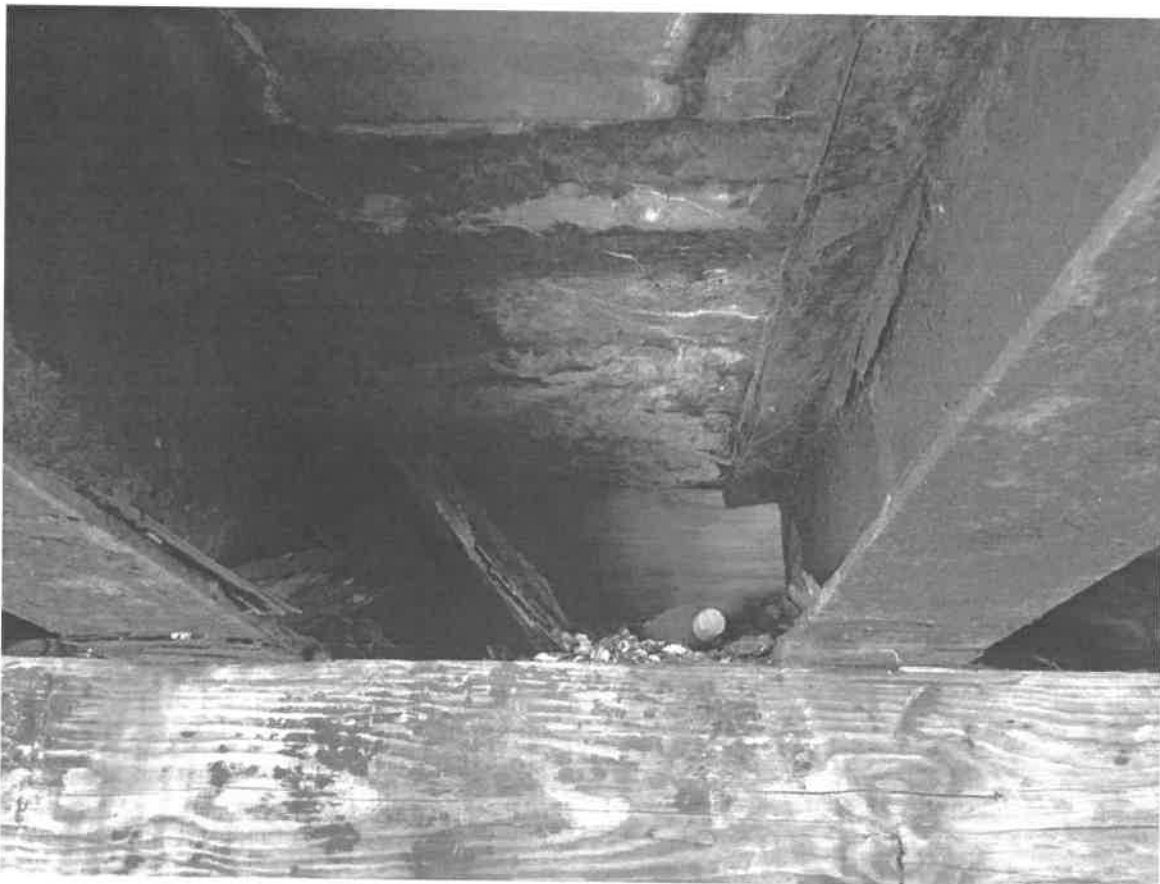
IMG_2122 Showing deterioration of concrete deck and steel beams.
