Indian Lake Property Owners Association

Bridge Inspection and Report

Cochran Project Number: SC17-683

April, 2017

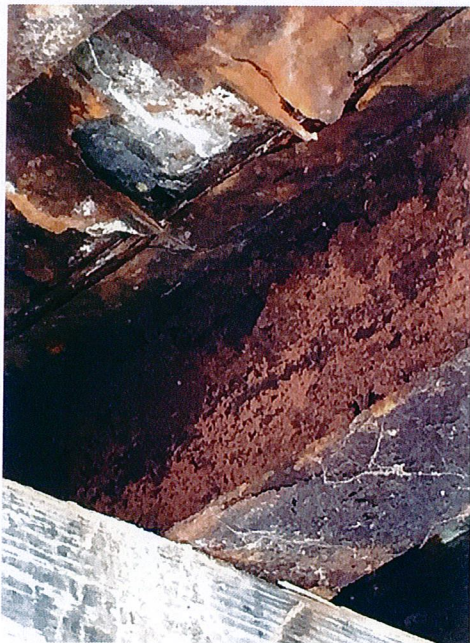
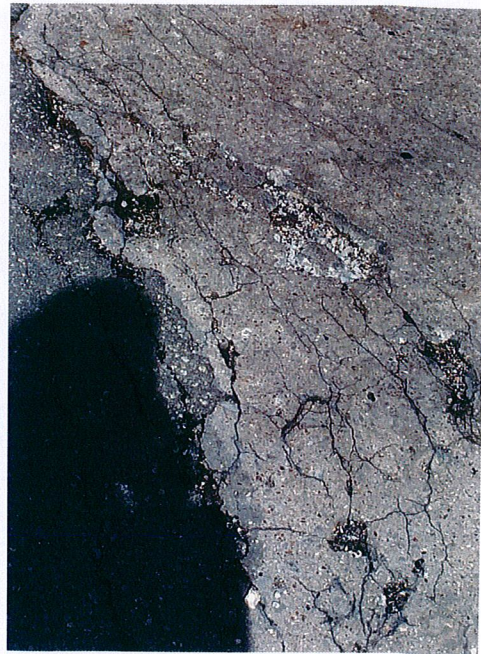
The third issue is the cracking in the concrete deck that is allowing water to infiltrate and saturate the concrete deck. This water infiltration has caused the metal stay in place forms to rust and the metal has completely rusted away in locations near the west abutment. Since the metal forming is not a structural component of the bridge, the deterioration of the metal pan is not a big concern. One of the main problems with using metal stay in place forms is that any water seeping into the concrete deck is trapped near the bottom of the concrete deck by the metal form. This leads to saturation of the concrete with causes it to deteriorate as well. With the metal forming completely gone in places, the water has started attacking the steel stringers causing them to rust as well. Application of roadway salt during the winter months contributes to accelerating the rusting of the steel members. The rusting of the steel beams is progressing to the point where section loss is occurring. Evidence of pack rust and delamination of the steel stringers is evident. See the photos below.

Water Infiltration and Beams Rusting – The localized areas near the west abutment where the deck is cracked up and allowing water to saturate the deck and has rusted out the metal forms needs to be repaired to stop the water penetration. While there is not an easy method to stop the rusting of the steel beams, preventing further water penetration into the deck will significantly slow the process down and prolong the life of the structure. It is recommended to remove the loose surface material on the deck and seal the cracked areas with a rapid setting, epoxy based concrete overlay system. A typical product in this arena is MasterSeal 350 Trafficguard which can be purchased through Carter-Waters, a contractor supply distributor. There is a Carter-Waters located in Washington, Missouri. Any epoxy based concrete overlay system would work in this situation to waterproof the deck and prevent moisture from reaching the steel members below. A commercial grade polyurethane or acrylic concrete sealer may be used for this purpose but it would need to be re-applied every few years to maintain its effectiveness. While it is important to treat the cracks and broken up areas of the deck, it may be prudent to treat the entire deck area to prolong the life of the deck. Follow all the manufacturer's recommendations that come with the product selected for best results.

Another option is to apply a heavy coat of CRS-2 asphalt emulsion and cover it with rock chips. This process, known as chip and seal, provides a waterproofing element to the bridge deck and would probably be the cheapest alternative, especially if it can be incorporated as part of a larger chip and seal project on your roadways.

Once steel has started to rust it is very difficult to stop the process, but one method to solve this problem is to sandblast the steel beams down to bare metal and then paint them to help prevent rust from starting. Without being able to remove the beams to sandblast and paint them in a shop environment, it would be very difficult to conduct this procedure on site and potentially environmentally hazardous to the aquatic life in the lake.

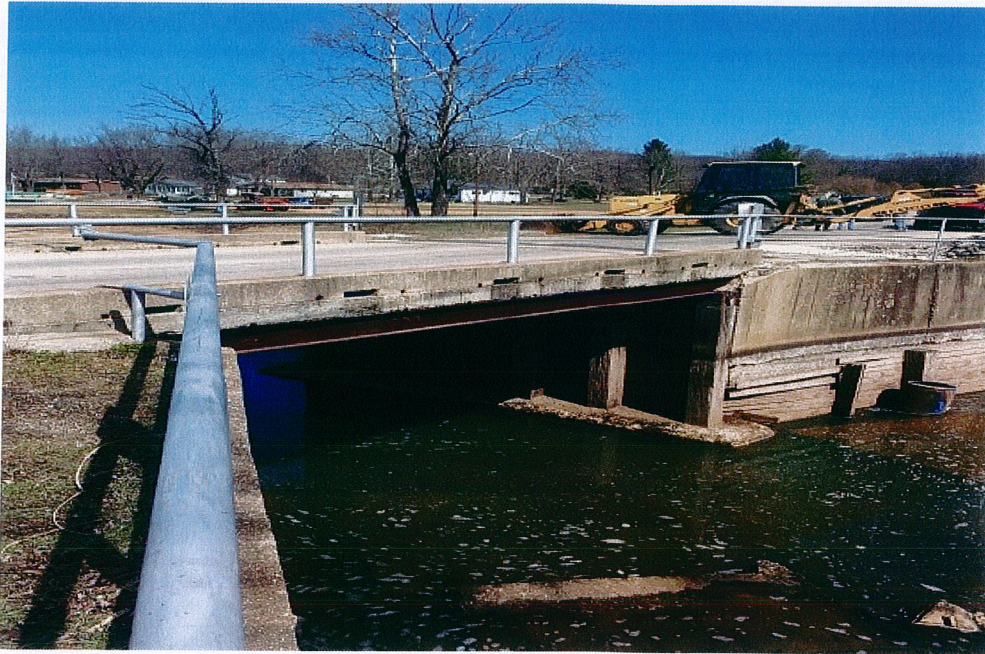
Another issue concerning the bridge is the lack of approved guardrail on the structure. Currently the bridge has approximately 12" high concrete curbs on both sides with a single rail of painted steel pipe approximately 3 feet above the bridge deck. While the condition of the pipe rail is good, it does not meet any of the typical standards that apply to safety barriers for bridges. This situation can create some liability issues for the ILPOA. See the photo on the next page.
