SEDIMENT & INVASIVE WEED REDUCTION

BIOTECHNOLOGY SOLVES LAKE'S SEDIMENT BUILD
UP AND INVASIVE WEED PROBLEMS.

Roland Lake, The Plains, Virginia

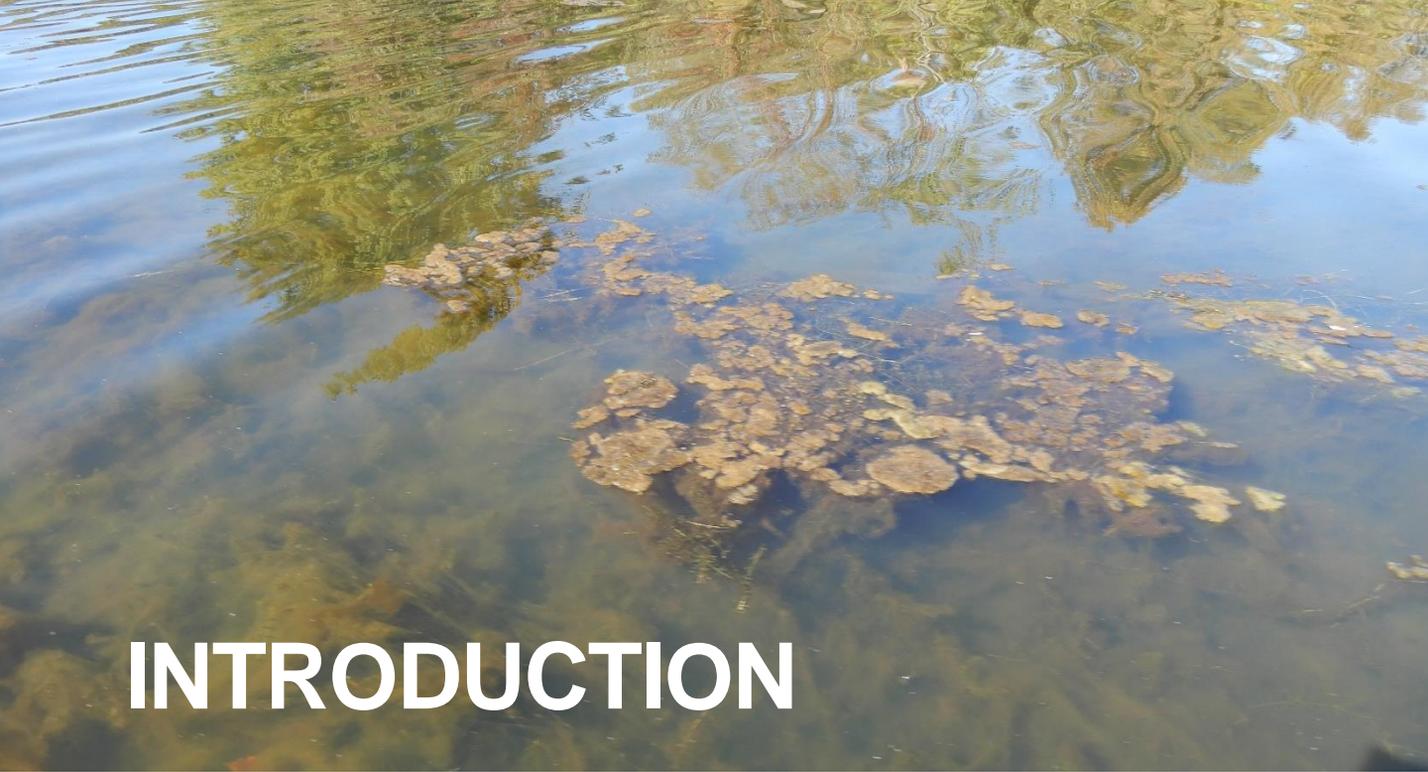
ROLAND LAKE OCTOBER 2017

Roland Lake is a 30-acre recreational lake in Virginia. In 2017 the lake was suffering from a long-term accumulation of mucky, nutrient-rich organic sediment that had allowed excessive dense invasive weeds to grow in virtually all areas of the lake 10 feet deep or less.

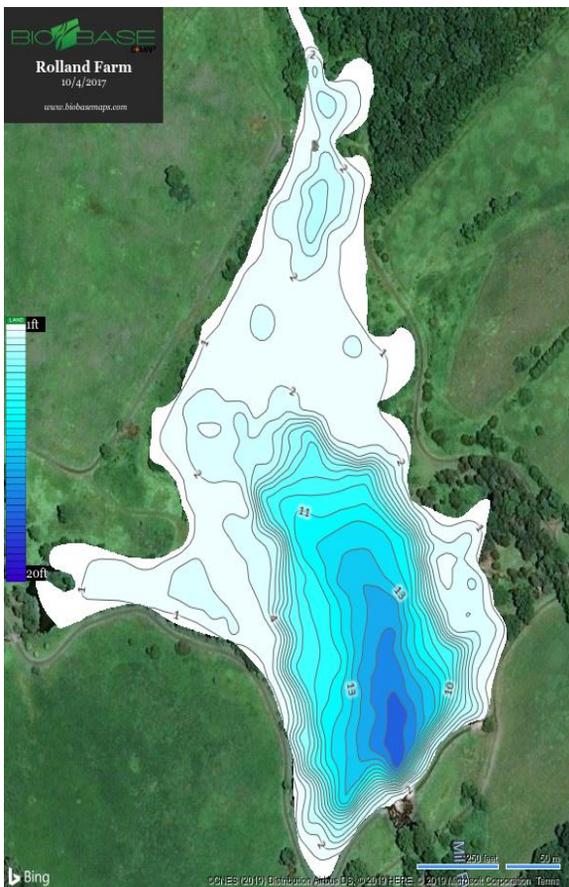
ROLAND LAKE
DEPTH PROFILE OCTOBER 2017

The depth profile of Roland Farm Lake in October 2017 showed that,

- the total volume of the water in the lake was 150.69 acre feet,
- the average depth was 4.14 feet, and
- the deepest point in the lake was just under 17 feet deep.

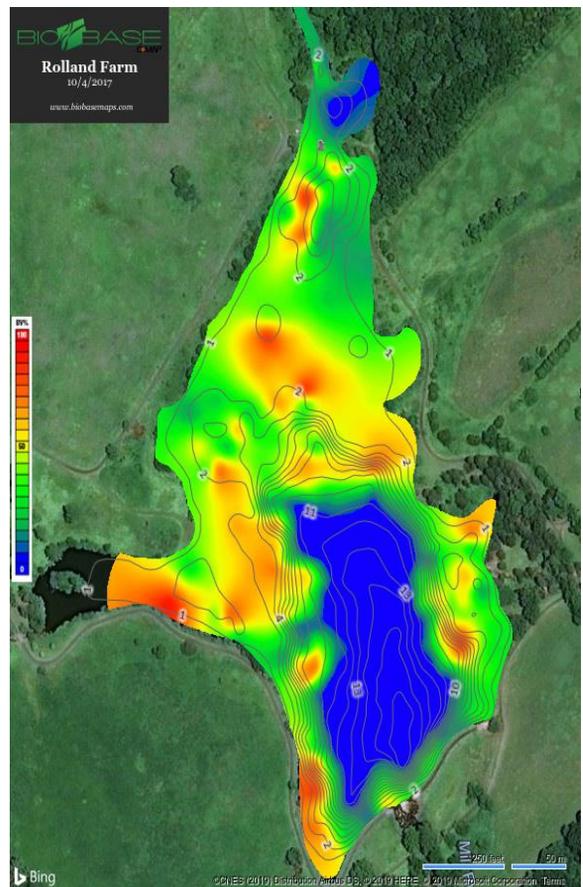
ROLAND LAKE
VEGETATION HEAT MAP OCTOBER 2017

Aquatic vegetation, which consisted of overwhelmingly invasive weeds such as milfoil, hydrilla and pond weed, occupied 40.3% of the volume of the lake. The vegetation “heat map” shows that only the area of the lake 10 feet or

deeper is free of weeds (blue).

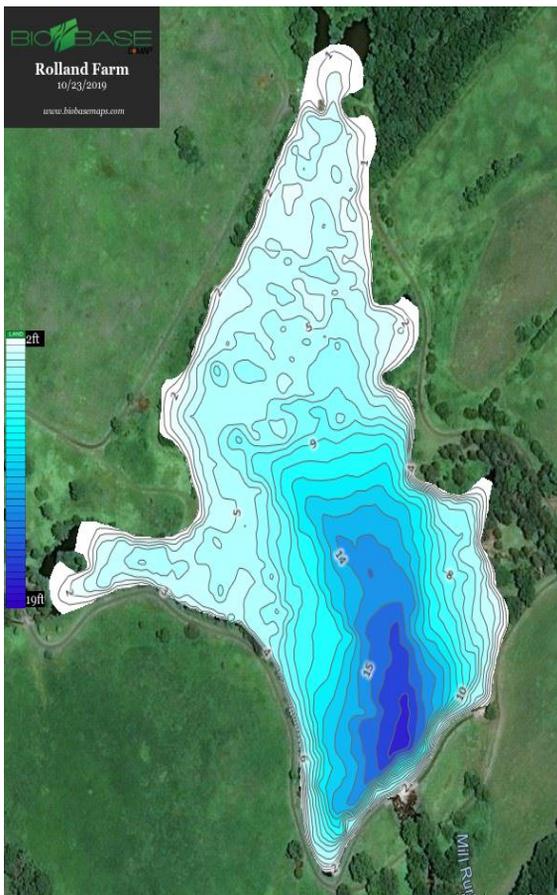
ROLAND LAKE, DEPTH PROFILE
OCTOBER 2019

The depth profile two years later, in October 2019, showed that,

- the total volume of the water in the lake had increased to 215.71 acre feet,
- the average depth was now 6.78 feet and
- the deepest point in the lake was 18.63 feet deep.

The increase in water volume is the volume of sediment digested, which is 65.02 acre feet.

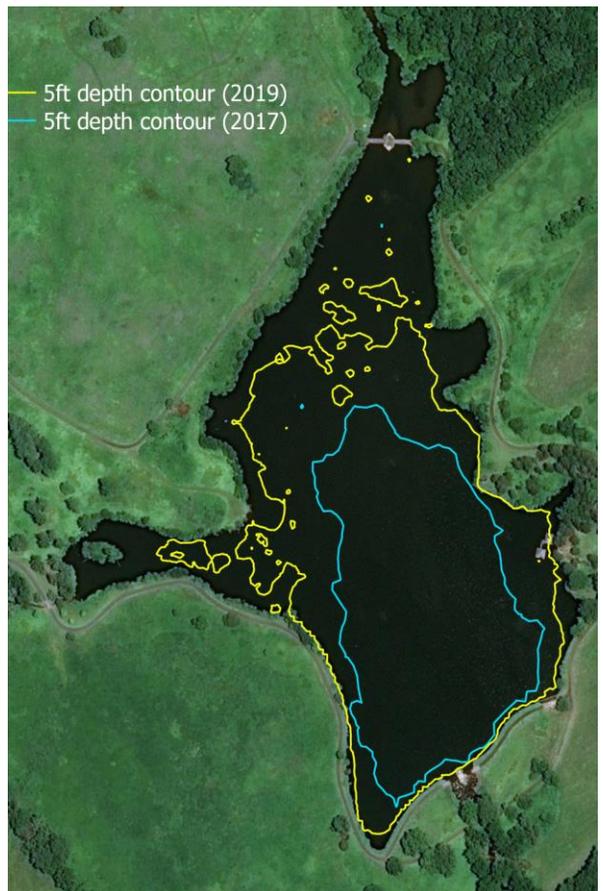
ROLAND LAKE, VEGETATION 5-FEET CONTOUR COMPARISON
OCTOBER 2017 V OCTOBER 2019

Prior to the implementation of SIS.bio's system, invasive weeds were able to root in and overwhelm the lake, steadily growing in the nutrient-rich mucky sediment. In the picture below, the 5 feet contour in 2017 is shown in blue. The area 5 feet or deeper in the lake covered a total area of 10.33 acres.

The yellow line shows the 5 feet contour in October 2019. The area 5 feet or deeper in the lake has increased to 18.96 acres, illustrating that prodigious sediment digestion and elimination has been achieved.

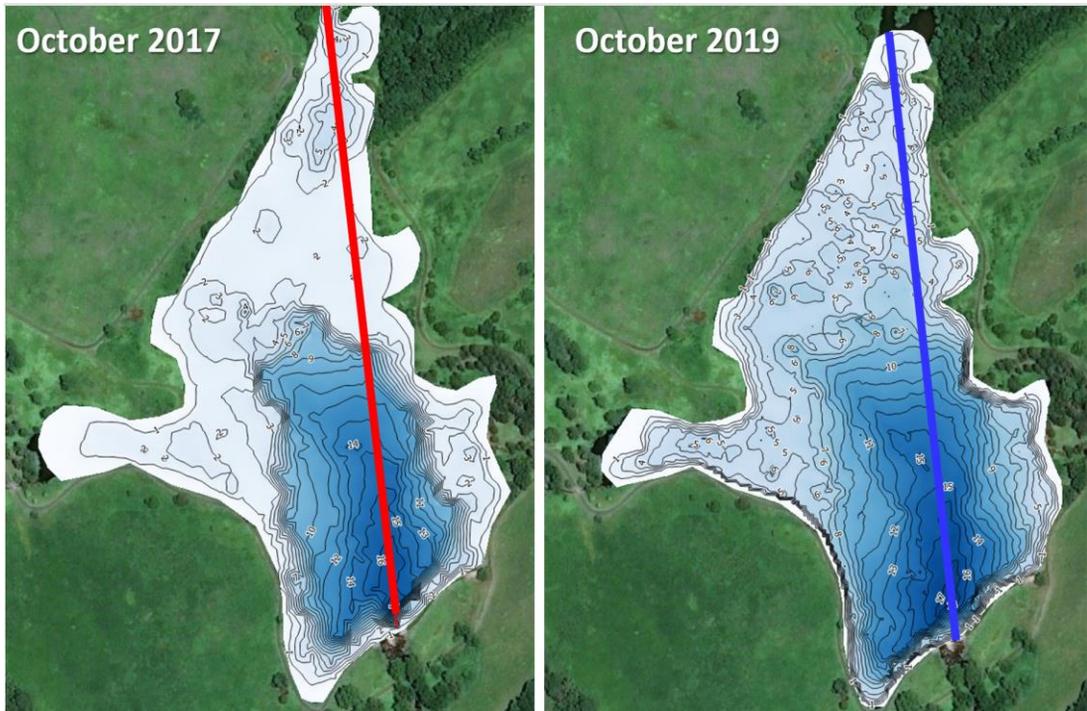
Using sophisticated software it is possible to draw a transect down the lake and rotate the view by 90 degrees in order to examine the profile of the lake bottom.

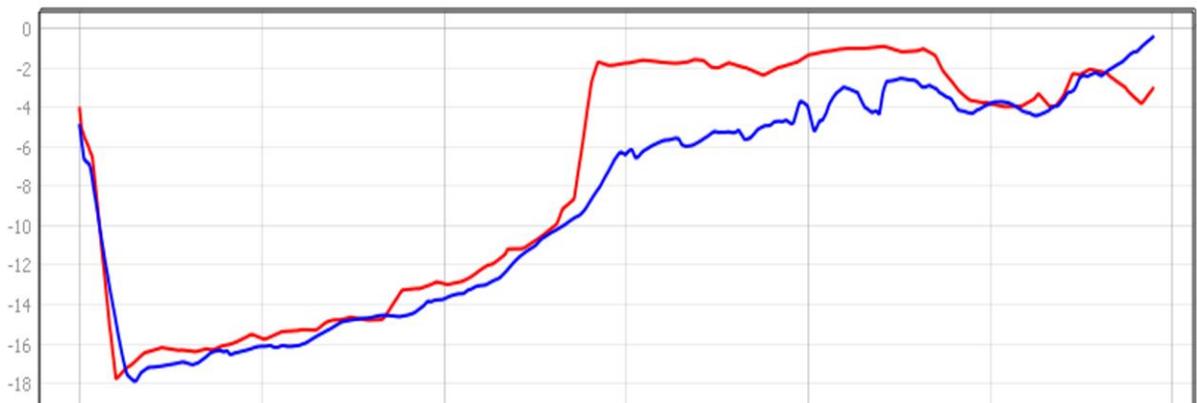
ROLAND LAKE, BOTTOM PROFILE COMPARISONS: OCTOBER 2017 V OCTOBER 2019

Using sophisticated software it is possible to draw a transect down the lake and rotate the view by 90 degrees in order to examine the profile of the lake bottom. The red line shows the bottom profile in October 2017 and the blue line shows the bottom profile in October 2019.

Significant digestion and elimination of sediment between 2 feet and 10 feet of depth is clearly visualized. Eliminating much of this nutrient rich rooting bed for invasive weeds was a significant factor in reducing these weeds.

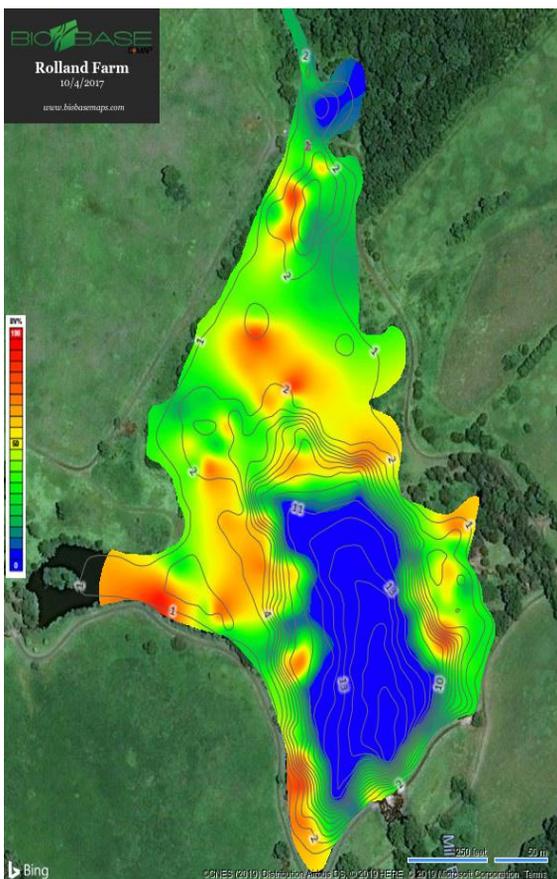
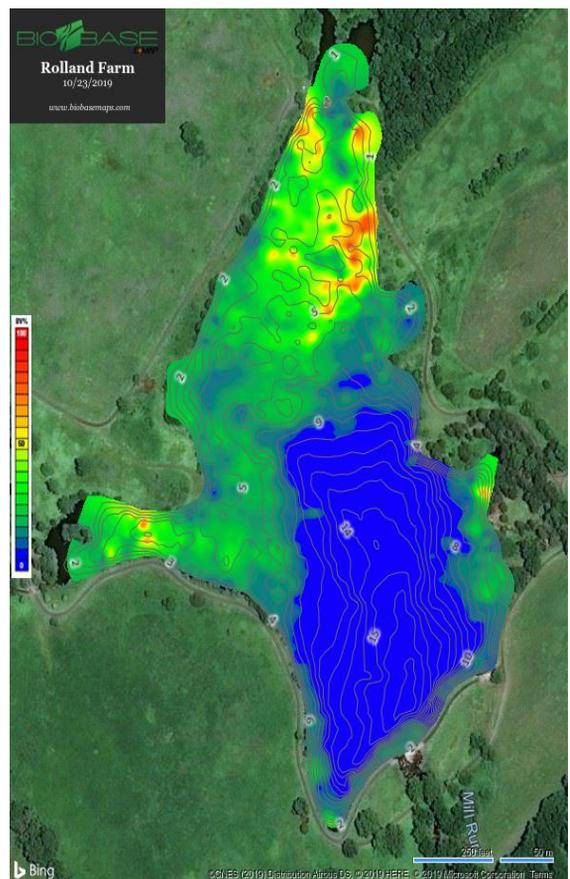
The vegetation heat maps from October 2017 and October 2019 are shown side by side below.

The shift away from red and orange coloration, which signifies dense weeds, to lower-density yellow and green, is easily apparent.

So too is the increase in blue, the area that is totally weed free.

The depth profile in October 2017 showed that the invasive weeds occupied 40.3% of the volume of the lake. In October 2019 that had dropped to 20.0% of the volume of the lake.
