# INDIAN LAKE PROPERTY OWNERS' ASSOCIATION

## 2022 Annual Report

December 2022

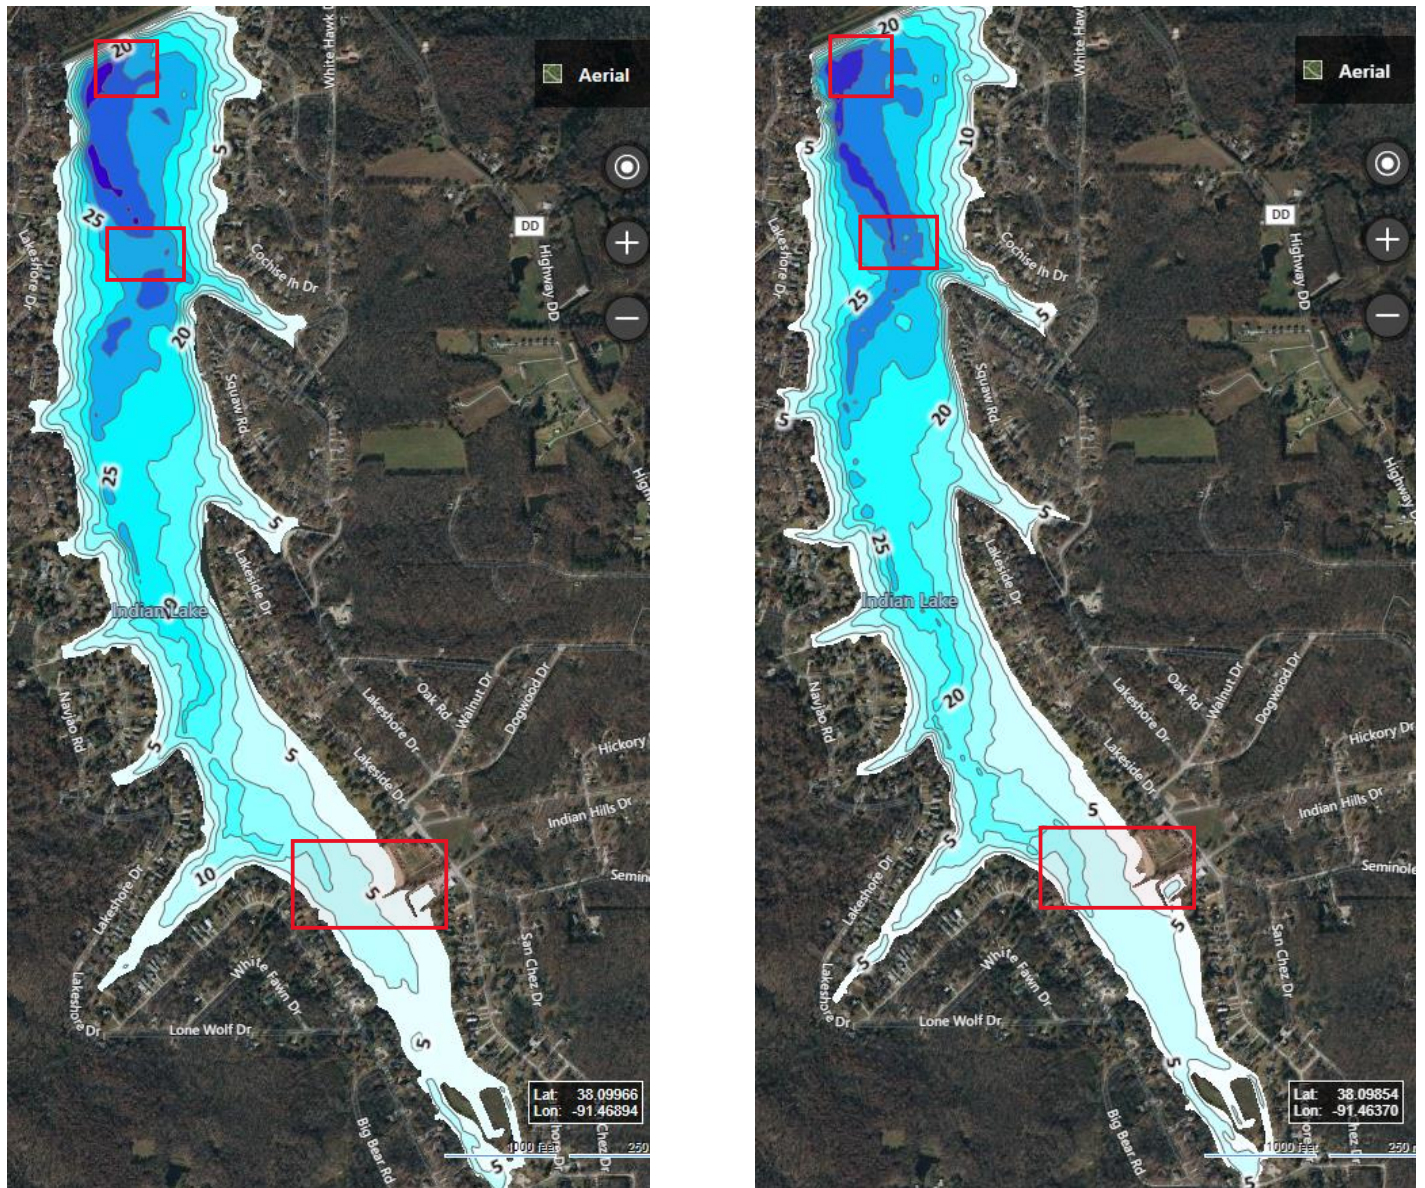
**Figure 1.** 2019 (left) and 2022 (right) bathymetric maps of entire lake. Red boxes indicate areas of focus in the following figures.

Changes in depth may be seen visually by comparing maps generated with the sonar data. Because the lake is large, when you zoom out to obtain a view of the depth contours of the whole lake, the BioBase software reduces the resolution of the contours to 5-foot intervals (i.e., it shows 5-foot, 10-foot, 15-foot, 20-foot, etc. contours).

Figure 1 shows side-by-side comparisons of maps of the entire lake in 2019 and 2022. The contour interval on these maps is five feet, thus the comparison is relatively coarse. Figures 2, 3, and 4 provide a more granular view of changes in the areas outlined with red boxes in Figure 1.

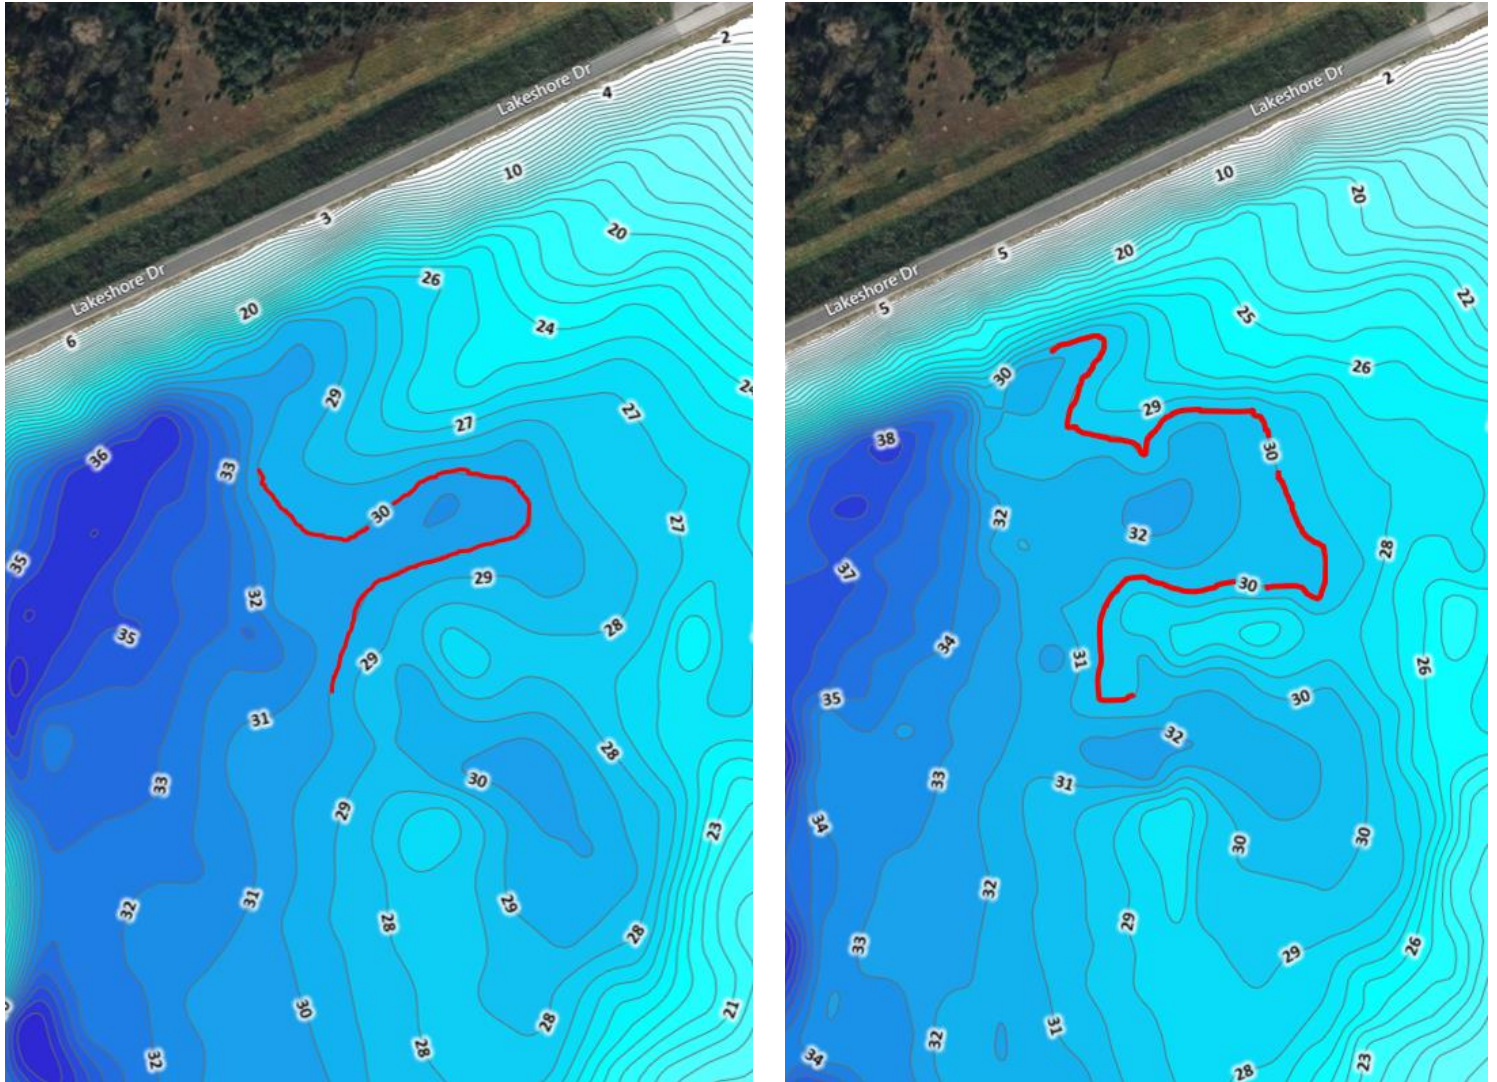
**Figure 2.** This is at the far north end of the lake, near the dam wall. 2019 (left) shows the 30-foot contour, with a small 31-foot contour inside of it. 2022 (right) shows enlargement of the 30-foot and 31-foot contours. Within the 31-foot contour there is now a 32 foot contour. Enlargements of other contours and the appearance of new, deeper contours can also be seen.

As stated in the initial report in 2019, below a depth of 12 feet our sampling showed up to 24 inches of organic rich sediment to be present. It is natural that more of this matter accumulates in deeper parts of the lake because there is a greater volume of suspended organic material that can settle out above the deepest parts, and because it is mucky and mobile, it can slowly flow and gravitate to deeper areas.

For this reason, the organic sediments at the deepest parts of the lake can build up to be many feet thick over time.

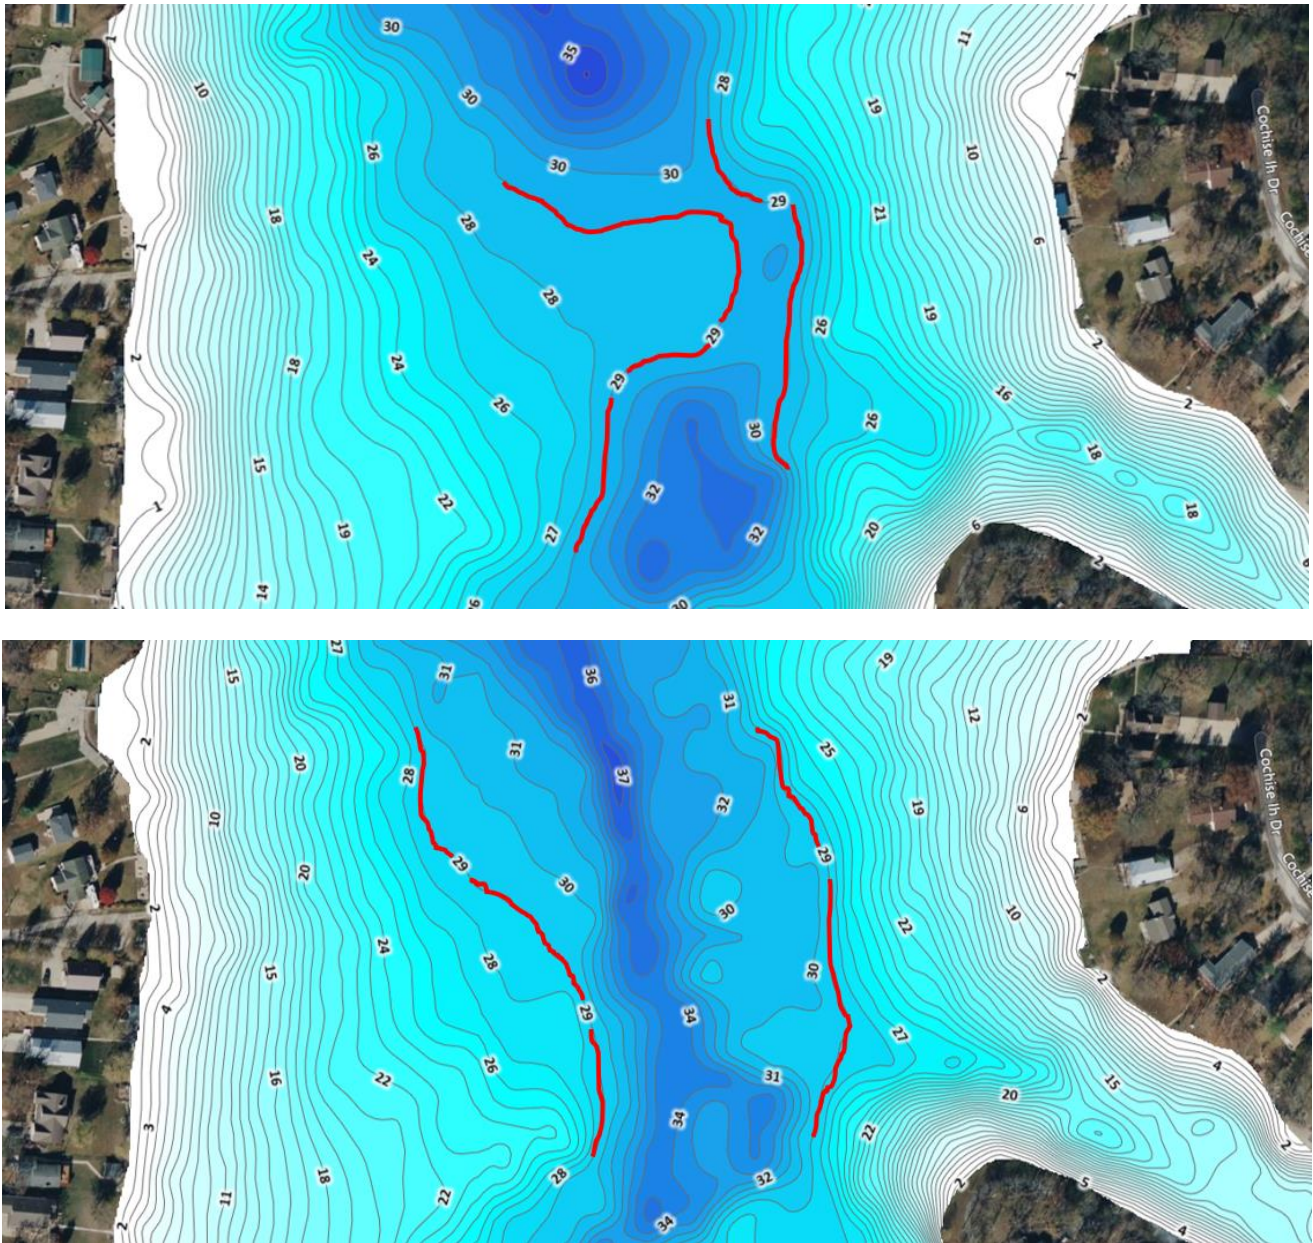
**Figure 3.** 2019 (top) shows the 29-foot contours either side of the original course of the river opposite Cove 2. At the narrowest point, there is a small circular 30-foot contour, showing a small “hole” in the sediment there.

2022 (bottom) bathymetric maps shows how deepening of the lake has widened the gap between the 29 foot contours on either side of the lake and created much more depth as the sediment has been reduced here.

Close examination of the two charts above shows that in this section there are parts of the lake in the deepest center channel that have increased in depth by 3 or 4 feet. Although inaccessible to conventional suction dredging, biodredging can deliver results at such depth, and potentially do so for several years to come.

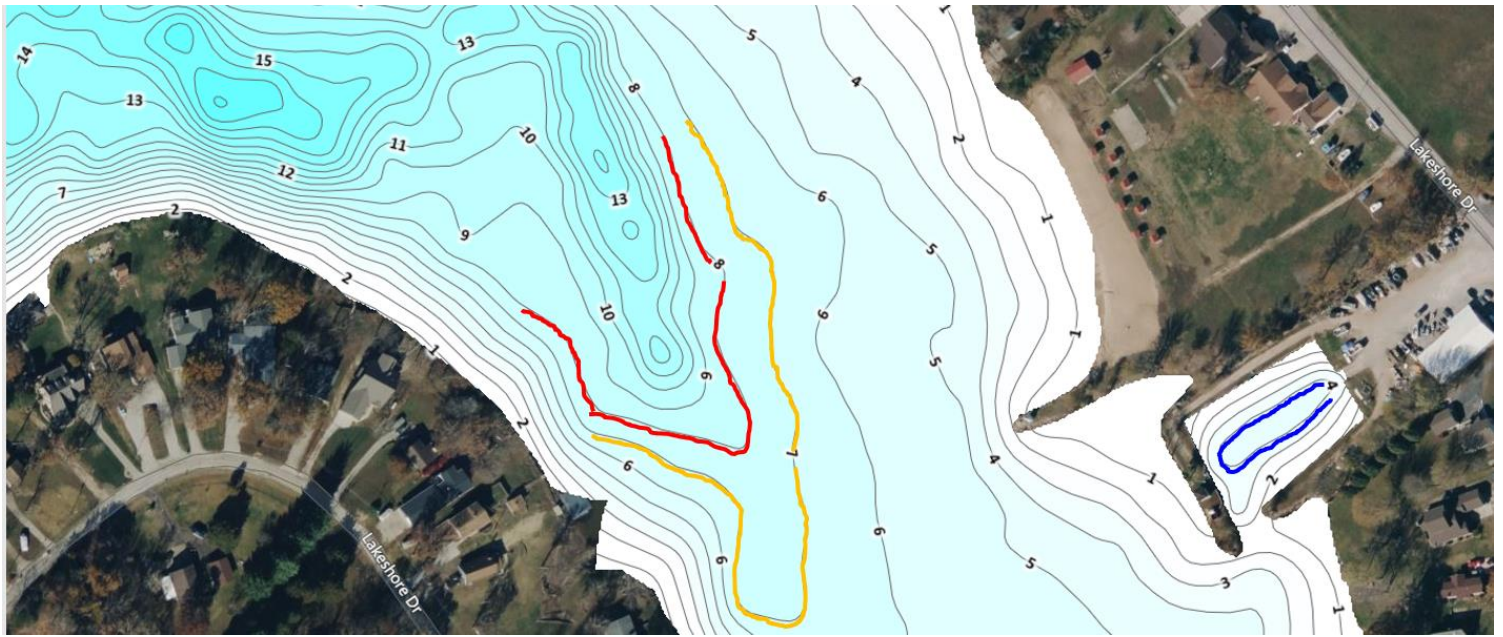
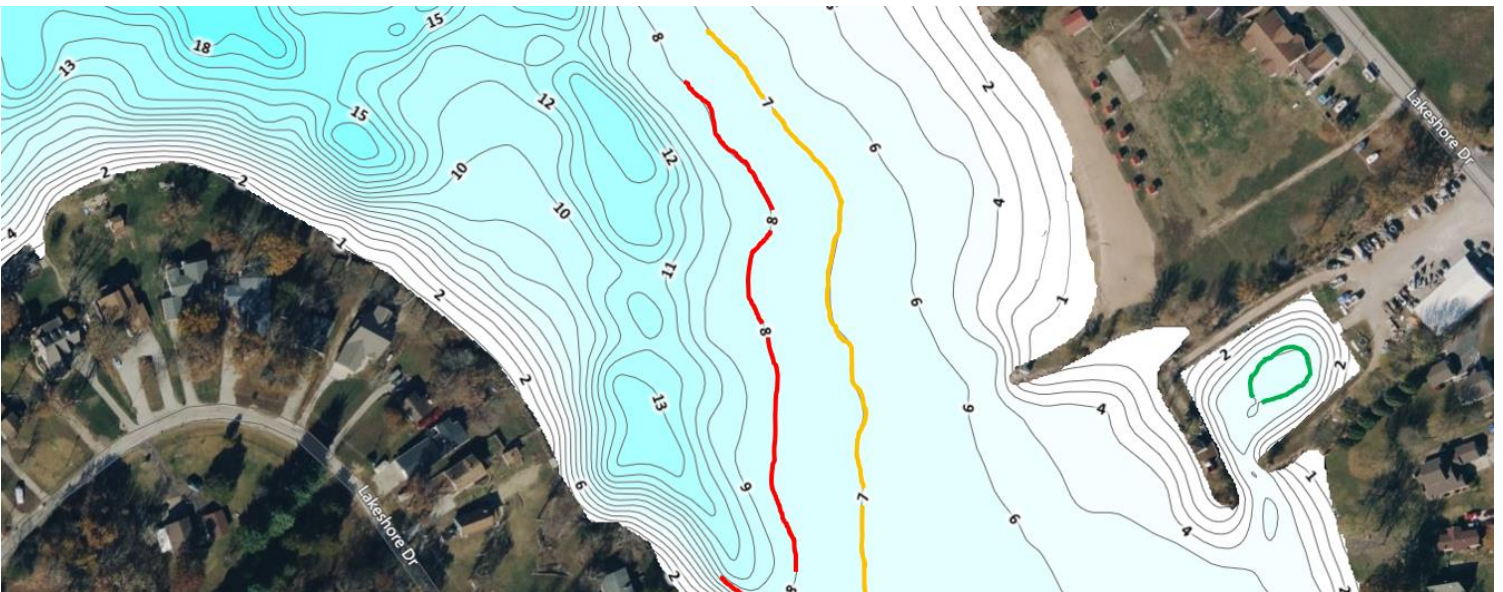
**Figure 4.** 2019 (top). The 8-foot contour is shown in red and the 7-foot contour is shown in orange. 2022 (bottom) shows how these contours have shifted into the lake as it has deepened. For the marina area the blue line (top) shows the 4-foot contour, whereas the green line (bottom) shows a new 6-foot contour.

These shallower areas accumulate less muck, and what does accumulate is readily mobilized by stormwater inflows and the action of wake boats, allowing it to gradually migrate to deeper waters. We would not expect to see as dramatic improvements here as in deeper sections shown above, and the rate of sediment digestion is likely to reduce faster here than in deeper parts.
