July 20, 2020

Indian Hills Subdivision
Cove 9 Bridge
Flood Damage Inspection
Cochran Project SC20-1110

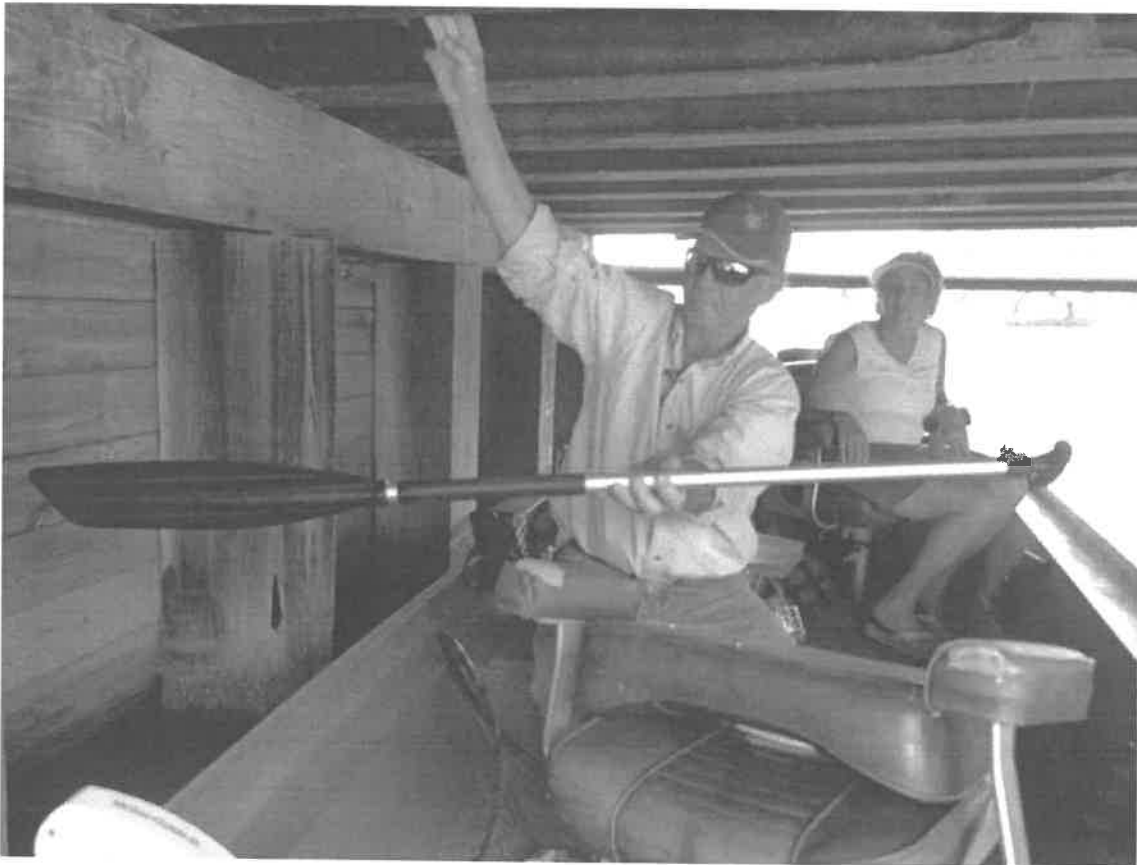
IMG_2110 The oar went over 3' into the cavity at the west end bent.

The ongoing deterioration of the bridge deck, beams and substructure indicate the need to control the weight of traffic on the bridge. Additionally, the cavity behind the west end bent could allow the roadway to collapse at any time. It is our recommendation that a Load Limit of 12 Tons be placed on the bridge to prevent large trucks such as trash trucks and dump trucks from using the bridge and accelerating the deterioration.
